Wind turbine plant of Nadachi

North-West Coast of Japan

This experiment is carried out on the Nadachi wind turbine on the west coast of Japan and is designed to measure the effectiveness of lightning protection afforded by a Prevectron early streamer emission lightning conductor manufactured by INDELEC.

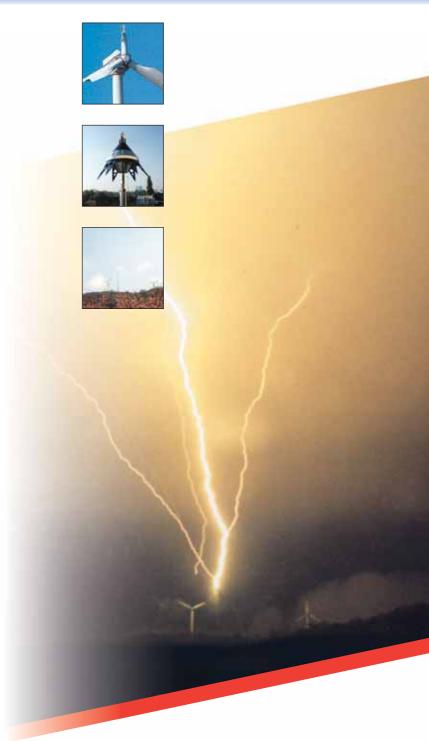
Damages on a wind turbine due to lightning strikes

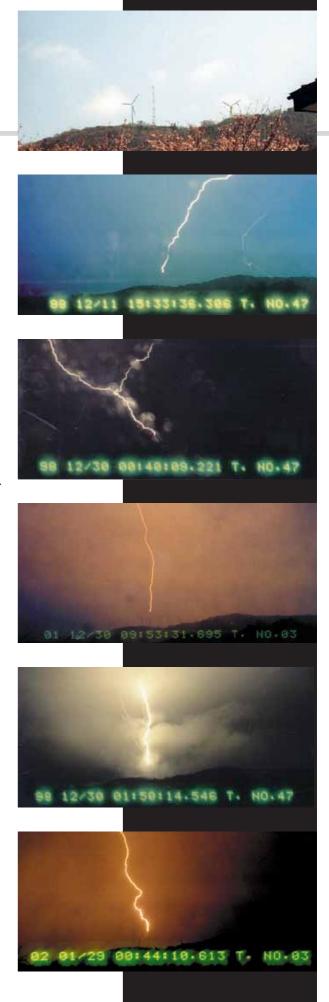
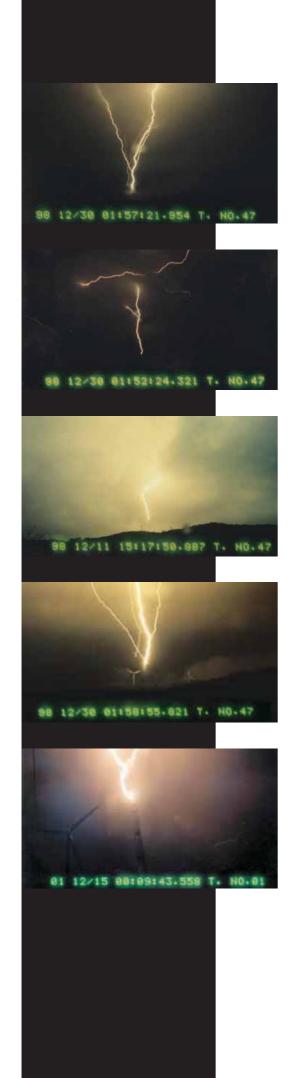
This report presents the results of more than 4 years of monitoring from 1st quarter 1998 to 1st quarter of 2002 with dozen of exposures showing cloud/ground flashes. A few example of pictures are presented in this brochure.

In 1998, of the 32 impacts - most of which were of the upward type - 29 were caught by the ESE protection system, thereby avoiding considerable damage to the generators and auxiliary equipment. 2 impacted the turbine closest to the protection system and one impacted the turbine farther away. However, the three probably low intensity impacts that hit the generators only cause traces at the surface of the blades, but no structural damages to the turbines.

12 lightning strikes have been recorded on the site from December 14 to December 30 with an impressive 100% success rate for the Prevectron Millenium (the 12 strikes were caught by the ESE air terminal).
